NASA Technical Memorandum 87583

GRANVILLE L. WEBB, RONALD K. CLARK, AND
ELLSWORTH L. SHARPE

SEPTEMBER 1985

THERMAL FATIGUE TESTS OF A RADIATIVE HEAT
SHIELD PANEL FOR A HYPERSONIC TRANSPORT

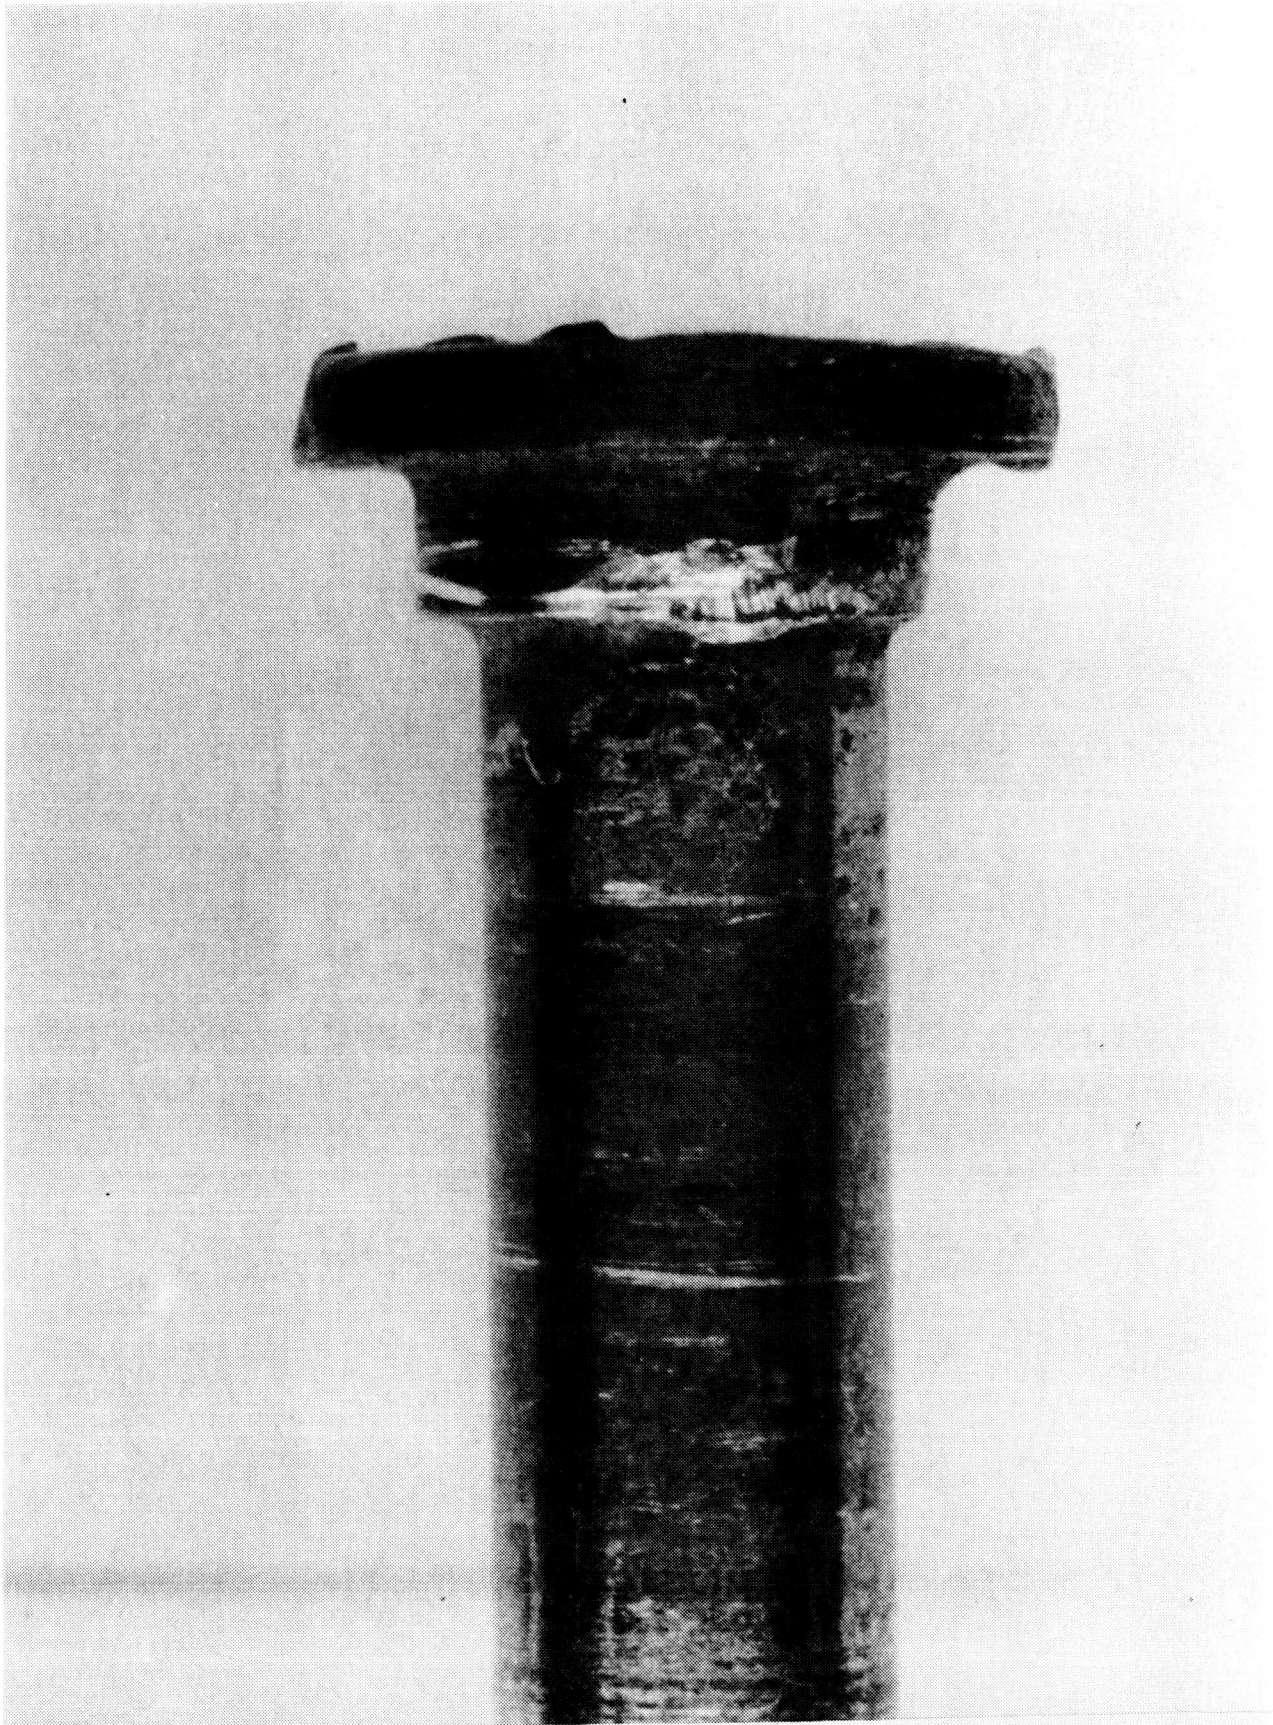
Figure 14 Shoulder bolt - minimum wear (20,040 thermal cycles)

The fasteners holding the René 41 heat shield to the aluminum plate were difficult to remove and had to be forced out to separate the heat shield from the aluminum support plate. Superficial examination of the René 41 heat shield indicated that the heat shield hole pattern was smaller than the hole pattern in the aluminum plate. Additional evidence of the mismatch of the holes can be seen in figure 10. Fastener number 3 appears almost centered in the slot of the René 41 while fasteners 1 and 6 are obviously not centered in their slots. The dimensions of both heat shield panels were checked and found to have decreased in width by about 0.10 inch. In fact, because of that shrinkage, the width of the hole pattern in the heat shields at the conclusion of the thermal fatigue test was less than for the aluminum structural plate.

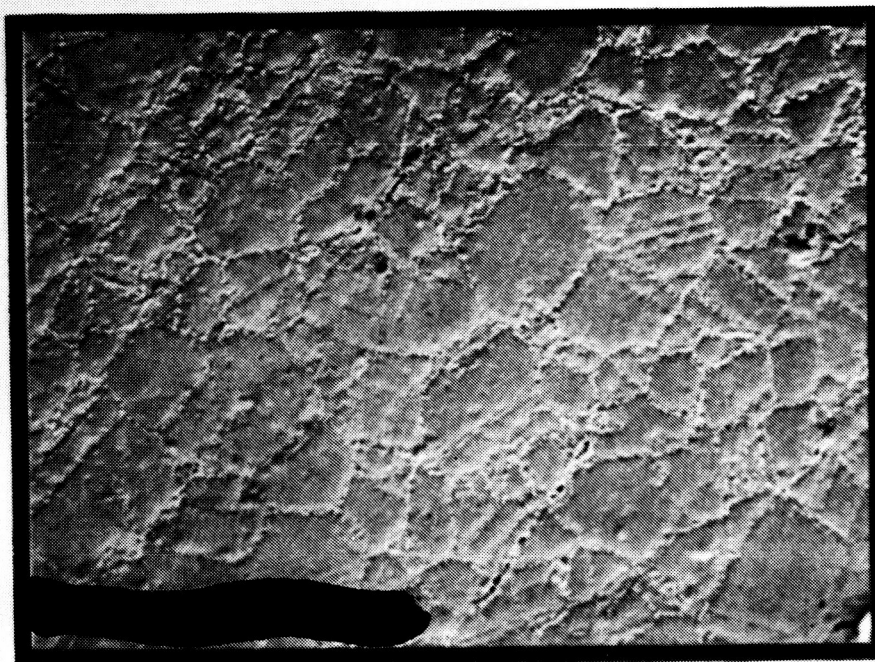
Thermal fatigue panel
(> 20,000 Thermal Cycles)
Figure 17 Microstructure of Rene' 41

Figure 17 shows light photomicrographs of mounted and polished samples of René 41 in the as-received condition and after thermal fatigue testing. The photomicrographs show an abundance of grain boundary precipitates in the thermal fatigue specimens compared to the specimen in the as-received condition which has clean boundaries. Based on a review of the literature for René 41, these precipitates are blocky carbides and the ψ' phase $[\text{Ni}_3(\text{Al}, \text{Ti})]$ (ref. 11). The presence of ψ' within the matrix is indicated by the darkened regions of the matrix bordering the grain boundaries (ref. 12). Long time exposure to temperatures in the region from 1400°F to 2100°F may result in forming continuous grain-boundary films around the grains which produce a brittle grain-boundary network. Grain boundary precipitation to the degree shown here has a direct effect on the mechanical properties of René 41.

Tensile tests of specimens machined from the corrugated skins of the heat shield showed an 80-percent loss in elongation and a 20-percent increase in yield strength compared to René 41 in the aged condition. Microstructural examination of specimens from the heat shield showed severe carbide precipitation on the grain boundaries which caused the loss of ductility.
